FIRE RISK ASSESSMENT

Dove Lodge
Community Resource Centre
49 Beach Road
Littlehampton
BN17 5JG

| Assessment date | 13 th May 2023 |

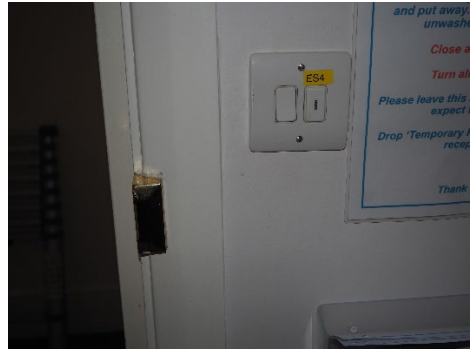
Room 3 The Emergency Lights were checked. This room appeared not to work we found they had accidentally been left on and had discharged.

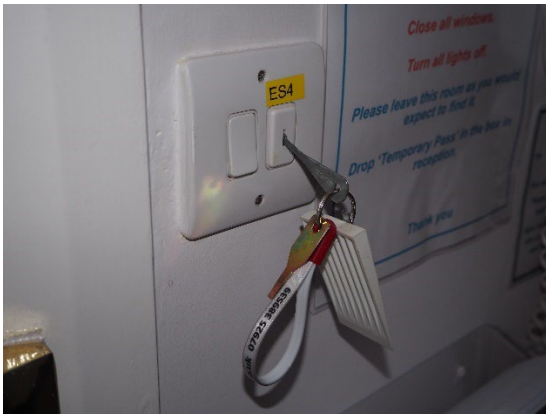
Room 3 The Emergency Lights were checked. This room appeared not to work we found they had accidentally been left on and had discharged.

The power was turned on and the E/L then showed a green indicator and was left working.

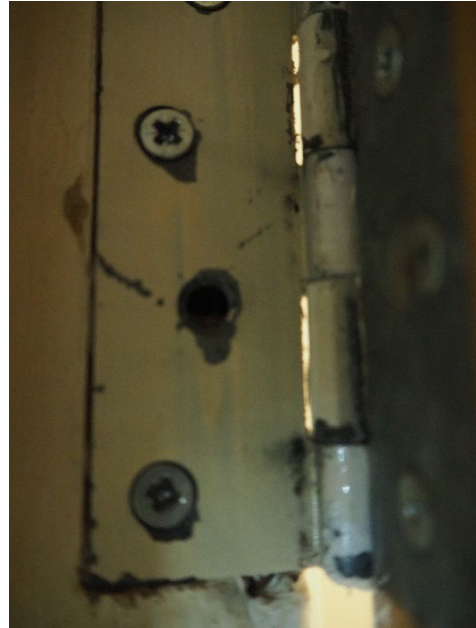
The hinges do not appear to carry the necessary markings as they have been over painted many times. Hinges should be fire rated. All hinges should be Certifire approved (BS EN 1935) Intumescent hinge pads must be used for compliance.

The screws holding the door to the door frame appear damaged / missing.

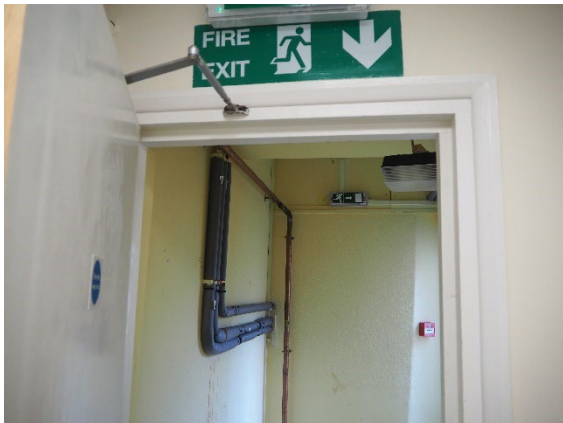
Technically this fire directional sign is from a different style (Block capitals) and directional arrow shows down from here whereas it should be arrow up meaning "Onwards from here".

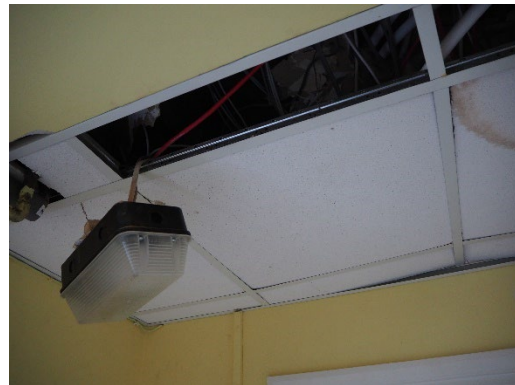
The ceiling suspended here is damaged with missing tiles, there is a light fitting hanging from its cable.

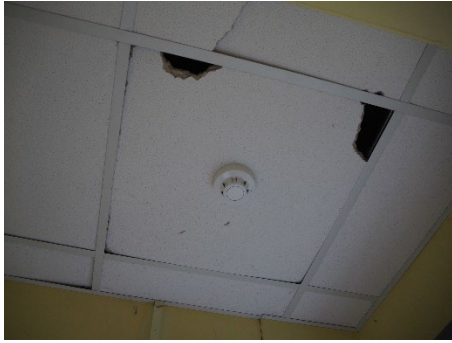
Although there is a smoke detector fitted the ceiling is damaged and will not afford the designed 30 mins fire protection and compromising the compartmentation.

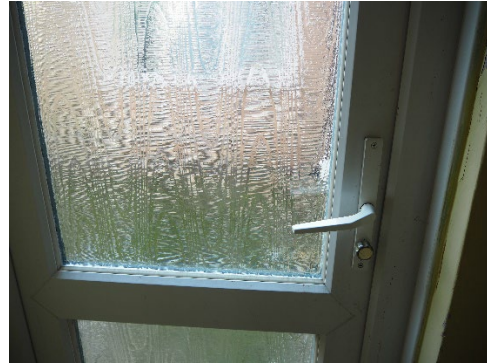
The glass in this Final Exit door is not safety glass and the latch sticks the door was found open. The thumbscrew latch should have a sign attached.

As previously mentioned the latch on this door sticks and does not always latch.

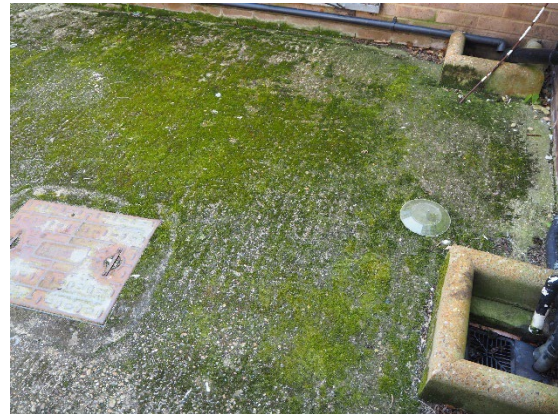
The fire escape route down this side of the building had moss and algae this should be cleaned off – a duty of care is owed and the escape route is considered a place of ultimate safety until all evacuees reach the fire assembly point a place of ultimate safety.

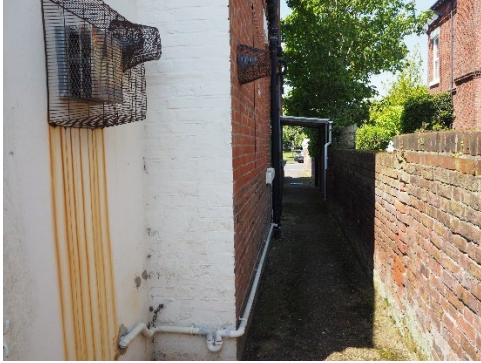
The metal, protective cage around the boiler flue is rusting.

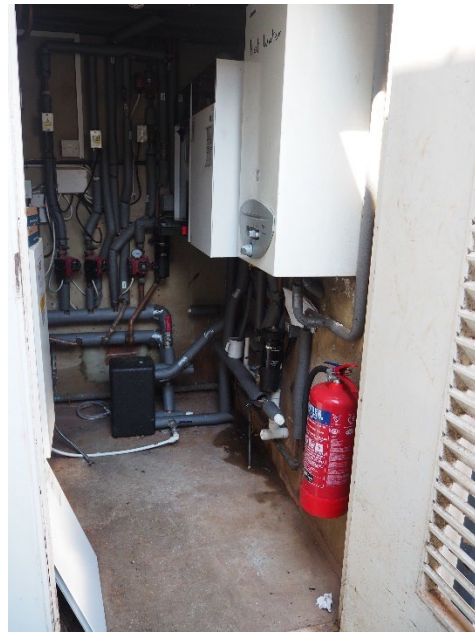
The boiler room contains a dry powder fire extinguisher – these are suitable for this type of fire risk, but not for use in confined areas.

There is a Dry powder fire extinguisher located in the boiler room, we recommend that Fire staff / Warden training highlight the hazards of using this type of extinguisher in confined spaces and consider locating this in a weather proof cabinet on the outside.

Staff training should reinforce the hazards of confined spaces and use of Dry powder fire extinguishers.

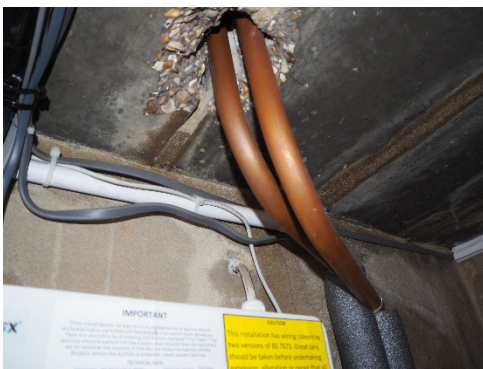
The reinforced concrete ceiling has been broken through to accept the heating pipes, but this has not been fitted with an approved intumescent collar or any other fire stopping material.

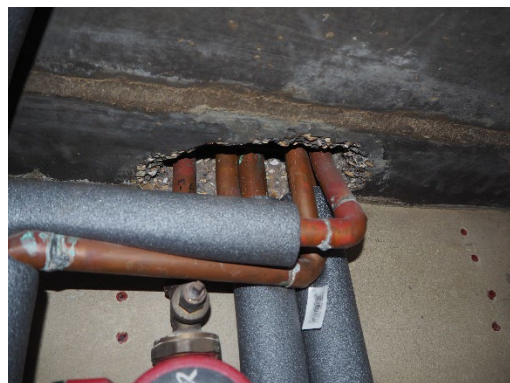
The reinforced concrete ceiling has been broken through to accept the heating pipes, but this has not been fitted with an approved intumescent collar or any other fire stopping material.

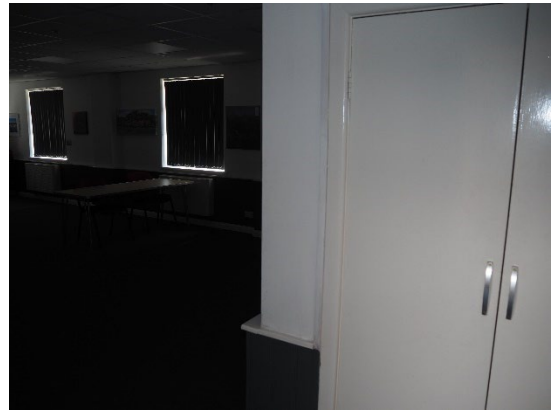
There is a store cupboard located within the room. This is not to FD 30 standard, although no flammable goods are left here.

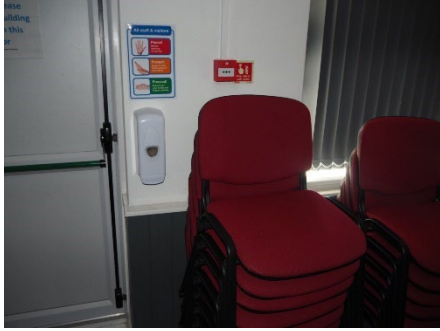
Please be careful with items such as coat stands placed on fire escape routes and adjacent to final exits or having chairs stacked.

In an emergency evacuation can become blocked with movable objects such as loose chairs.

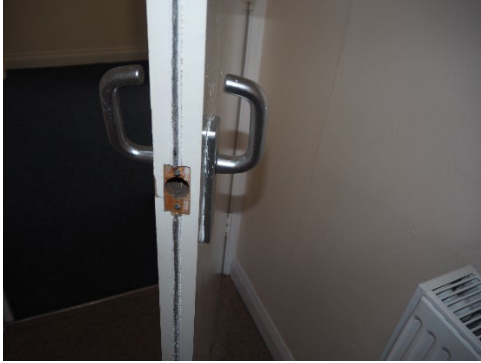
Room 7. The handle is broken and the latch has been removed from this door and should be replaced.

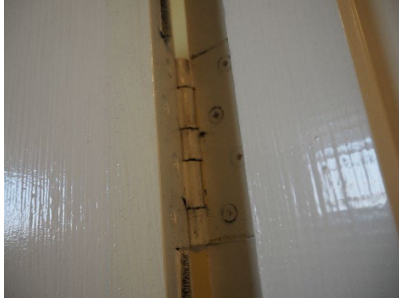
In this room the door hinges did not bear the fire safe hall marked.

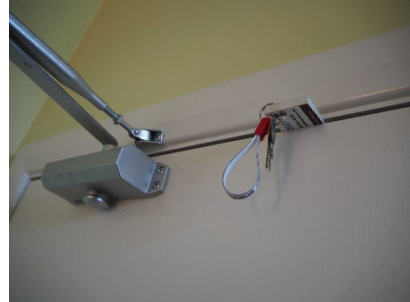
The gap, at the head of the door was more than the recommended tolerance of between 2 – 4 mm.

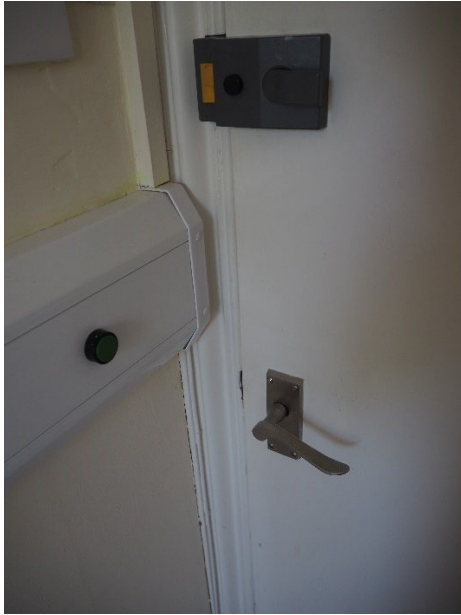
Locks and latches should conform to BS EN 12209. There were no CE DOP (Declaration of Performance) or 3rd party certification from schemes like "BWF Certifire".

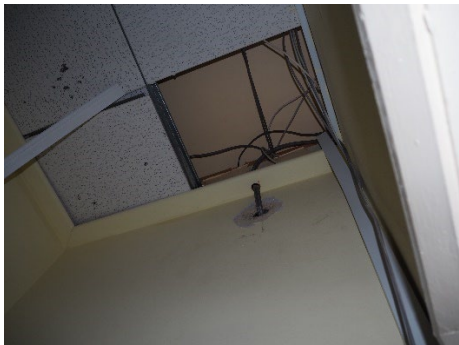
Cable management, ceiling tile and fire stopping required.

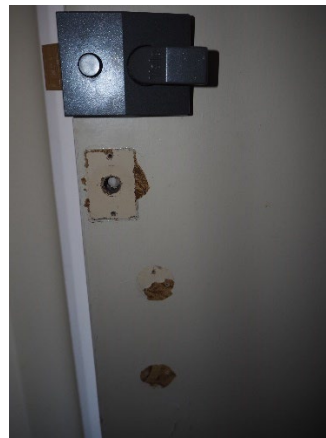
This door requires suitable repair.

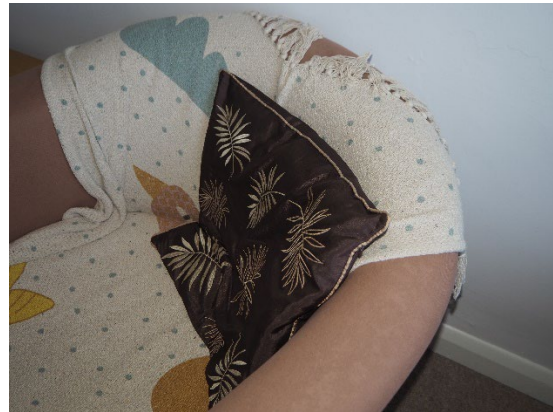
No warning labels were found on cushions or throws.

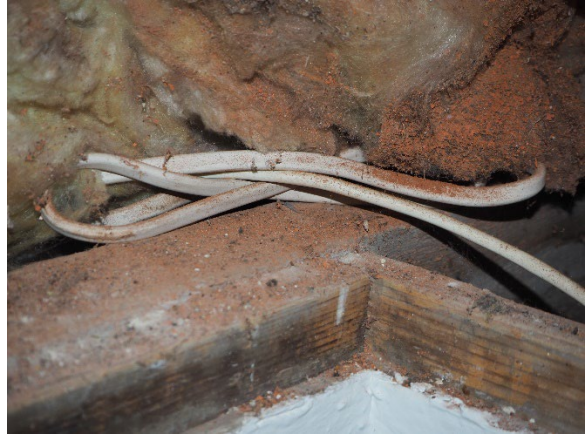
Where the conductors or cables are not supported continuously due to the method of installation, they shall be supported by suitable means at appropriate intervals in such a manner that the conductors or cables do not suffer damage by their own weight.

Wiring within the loft area is not laid on a grid it is not clipped appropriately, and most cases is covered with insulation. This can cause over heating especially when bundled together not separated or clipped.

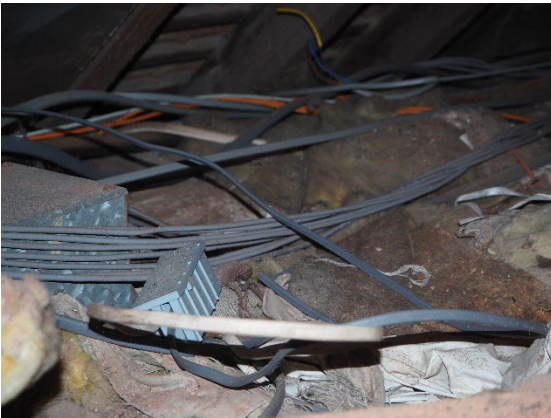
Cables are laid hazard often in bundles and criss-crossing other services.

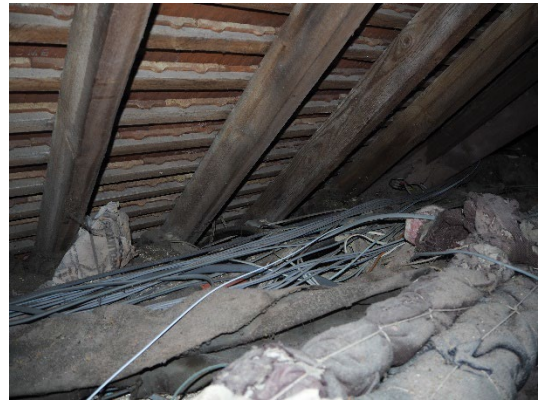
Cables are laid hazard often in bundles and criss-crossing other services.

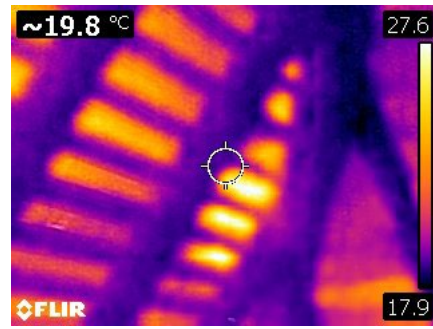
Thermal imaging was used throughout the roof space there was thermal gain from sun with outside temperatures lower than those recorded inside.

The solar gain combined with numerous cables and insulation we consider a hazard with a high-risk rating.
 The periodic electrical inspection is due next year these items should be discussed with them at the earliest stage.
 We will provide separate advice on fire stopping.
 We will provide information on signage, viewing distances, the size of lettering, the style and location.
 We will also provide under separate cover information on Fire doors and maintenance.
