FIRE RISK ASSESSMENT

Dove Lodge
Community Resource Centre
49 Beach Road
Littlehampton
BN17 5JG

| Assessment date | 13 th May 2023 |

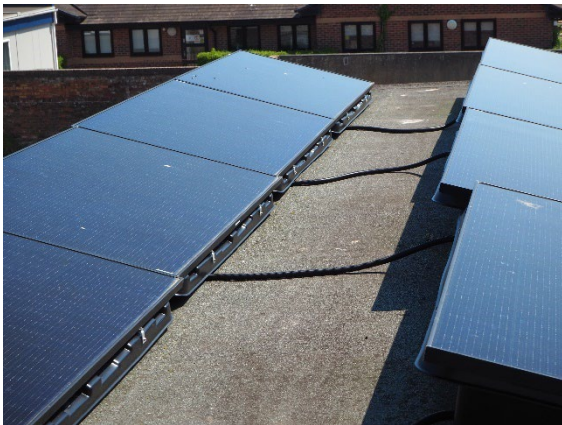
Solar panels are located on the roof of second floor at the rear of the building.

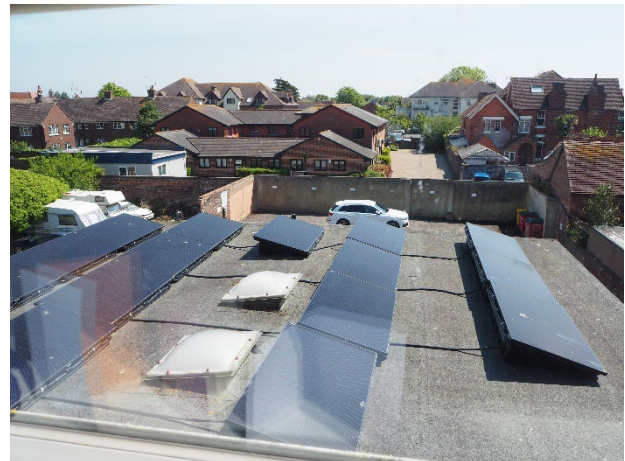
The arrangement of solar panels.

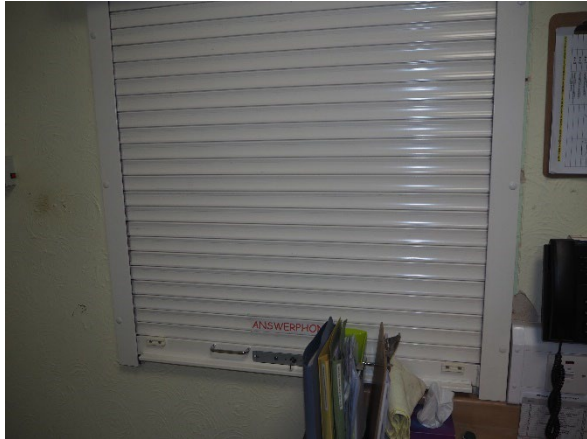
Inside view of fire roller shutter in down position.

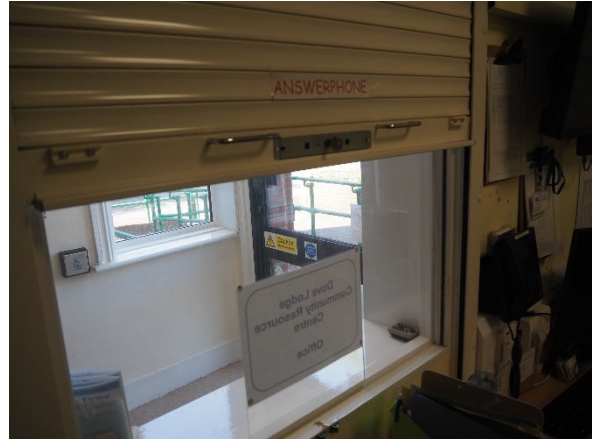
View of fire / security shutter.

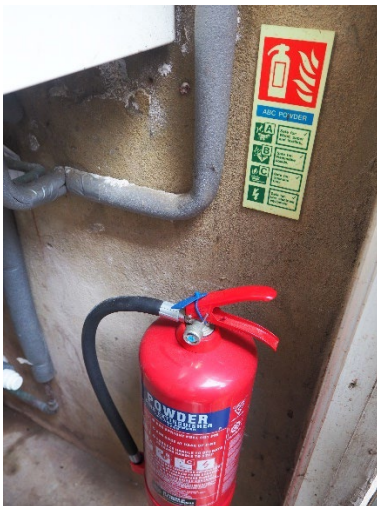
There is a Dry powder fire extinguisher located in the boiler room, we recommend that Fire staff / Warden training highlight the hazards of using this type of extinguisher in confined spaces and consider locating this in a weather proof cabinet on the outside.

Boiler room, dry powder fire extinguisher.

Staff training should reinforce the hazards of confined spaces and use of Dry powder fire extinguishers.
