FIRE RISK ASSESSMENT

Dove Lodge
Community Resource Centre
49 Beach Road
Littlehampton
BN17 5JG

| Assessment date | 13 th May 2023 |

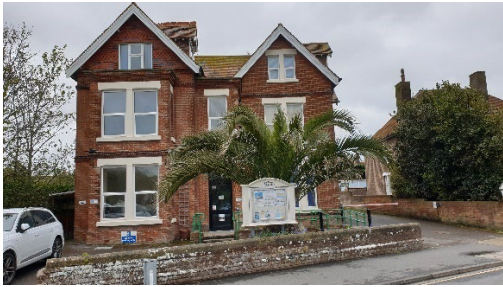
Front of the building.

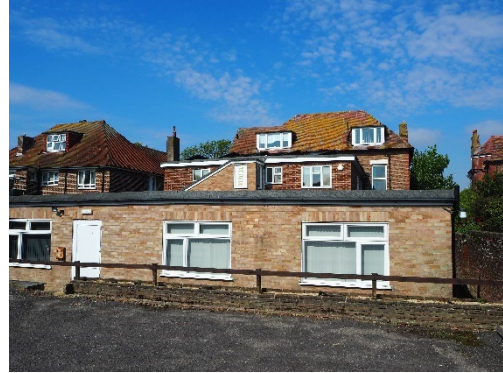
The rear of the premises.

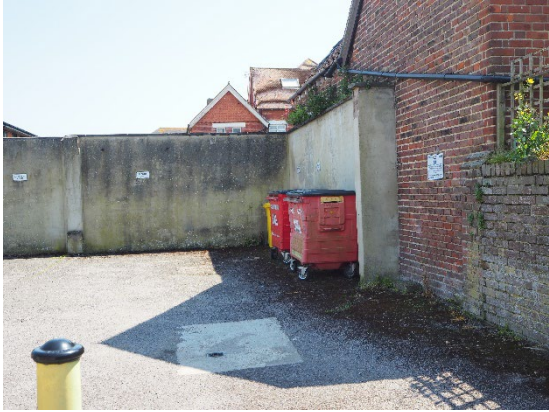
The storage bins well away from the building. These are located to the right of the building in the rear car park.

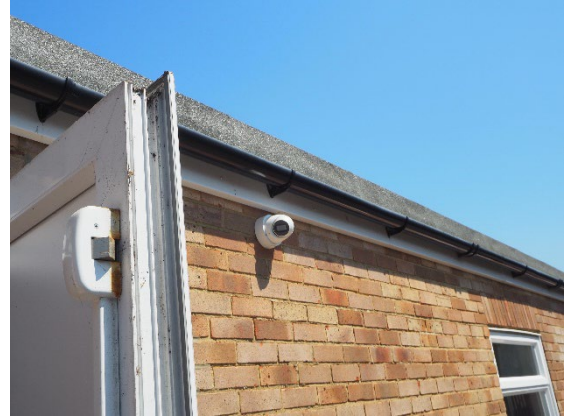
The outside of the building is covered by CCTV

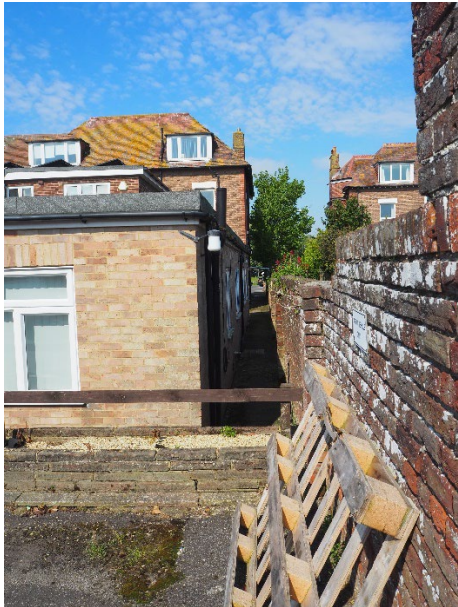
The door on the left of this image is the final exit leading down from then first floor of the building.

There is a narrow passage way situated on the North side of the premises running West to East.

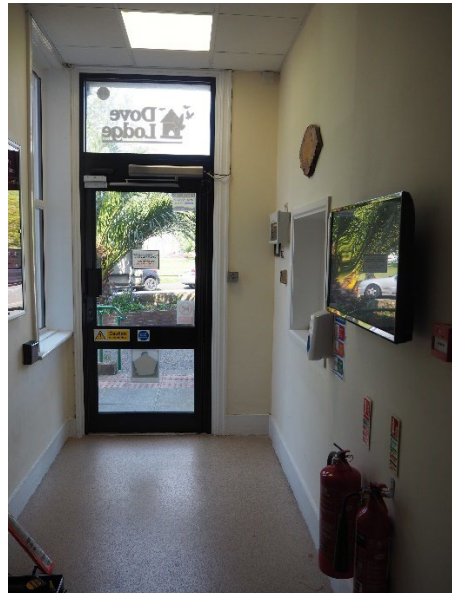
The entrance as view from inside facing out.

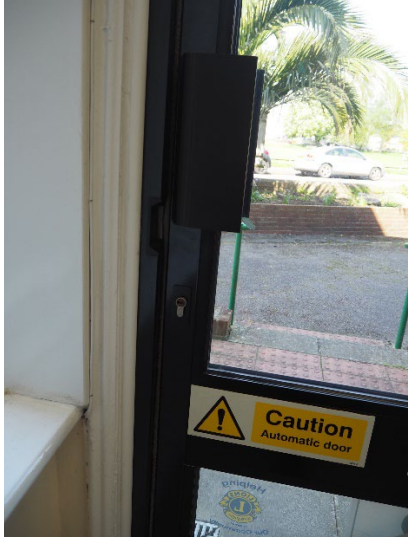
The front door is electronically controlled and is fail safe.

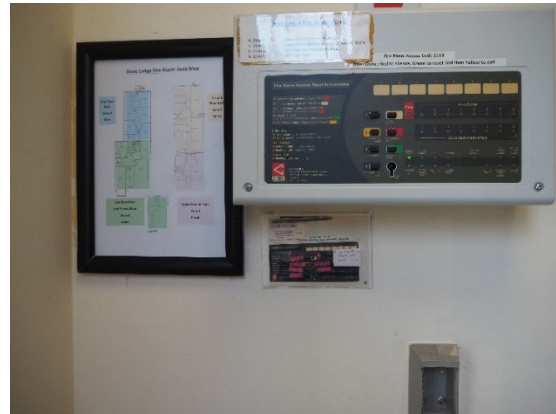
The fire alarm system was checked and working as expected showing no faults. There is a service agreement with Wakefield Security & Fire in place.

There is also a zone plan positioned next to the fire panel.

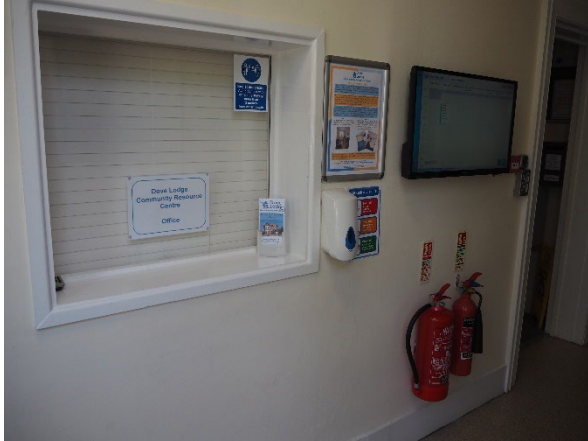
The Dove Lodge office is located inside of entrance and to the left. This is fitted with a Fire roller shutter.

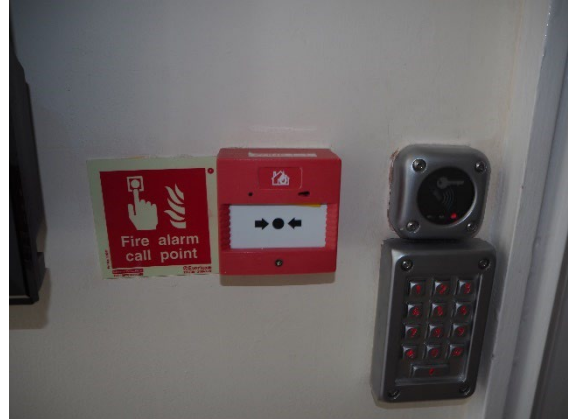
For security reasons the building has a combination of key and swipe access controls.

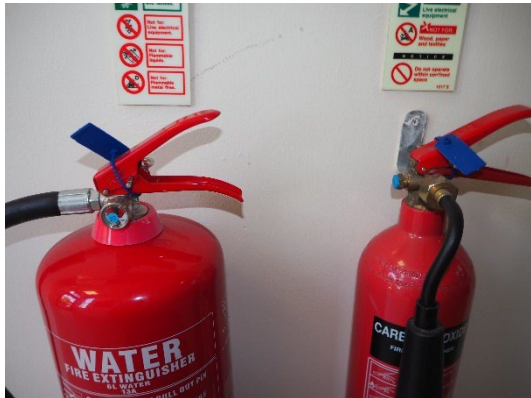
The fire extinguishers were checked for security tags & pins, the service labels were checked as well as Extinguisher I.D. signs.

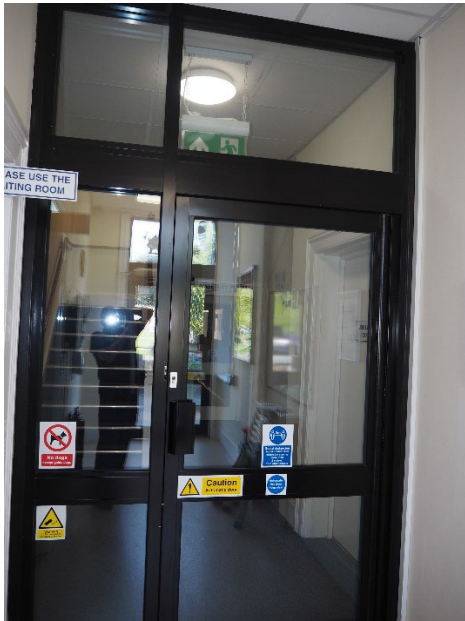
There is an inner door with a viewing panel and clear glass transom above the door. This is also controlled by electronic security device

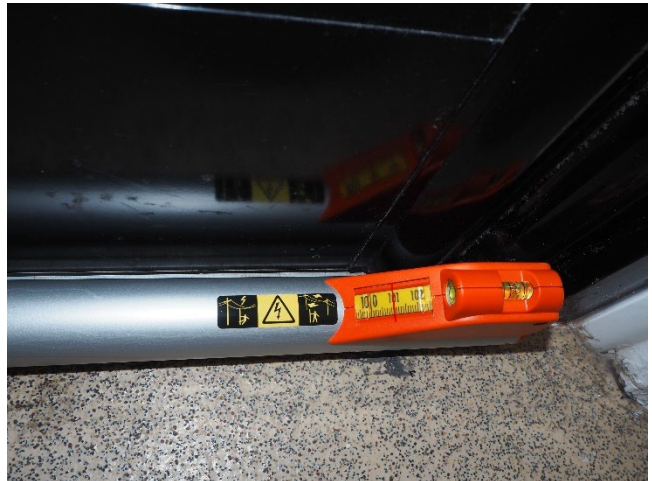
The width of this door is 1100mm the minimum width of a Fire Exit door is 1050mm. The minimum width of escape routes Approved Document B fire safety requires a minimum of 750mm for escape routes for up to 60 persons.

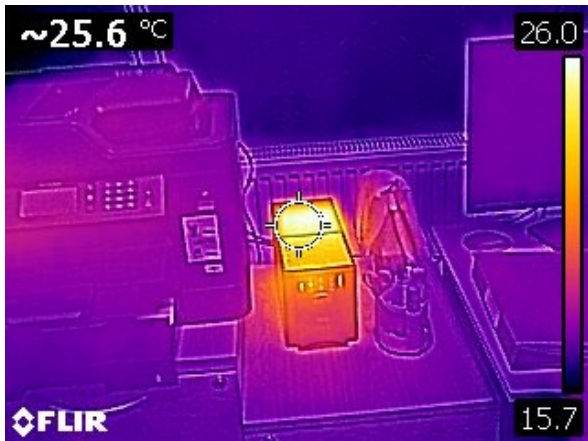
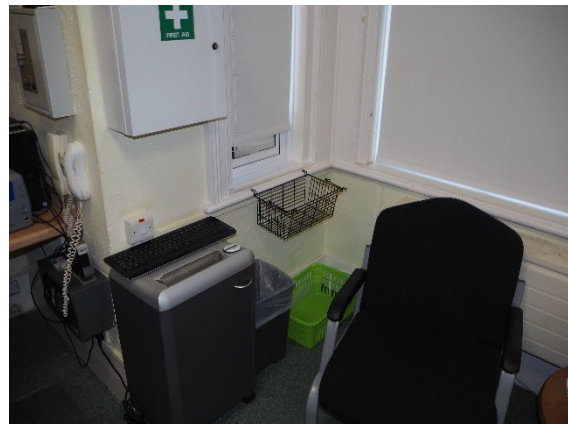
Thermal imaging was used throughout checking temperatures of items.

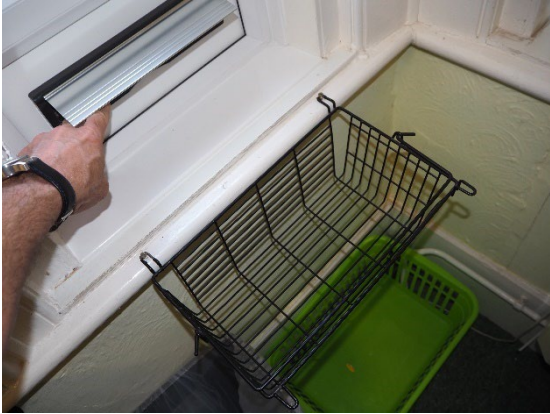
There is a letter box opening direct from outside into the admin office.

This arrangement could give rise to arson. Although normally associated with front doors the same can be with any openings for post or other wise.

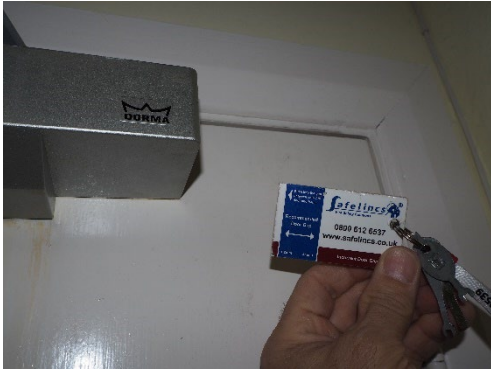
Fire doors were checked for alignment of doors, gaps at head and sides, the door closers were checked as were hold open devices.

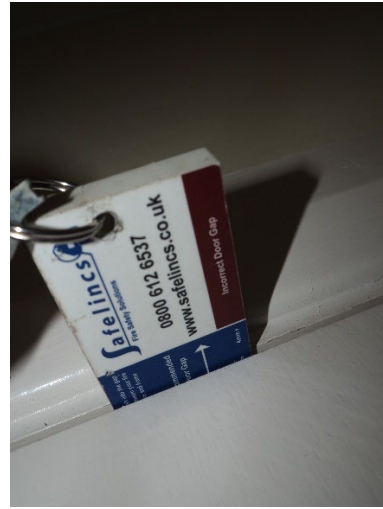
Fire doors were checked for alignment of doors, gaps at head and sides, the door closers were checked as were hold open devices.

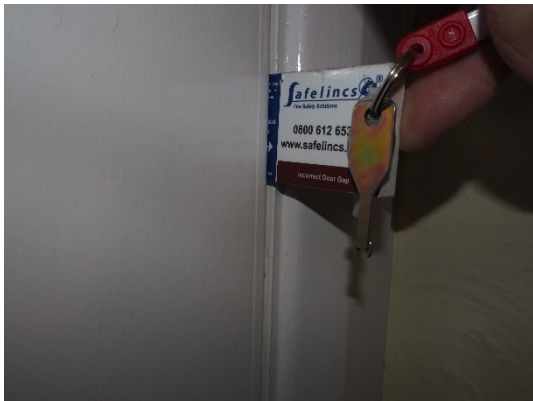
Fire doors were checked for alignment of doors, gaps at head and sides, the door closers were checked as were hold open devices.

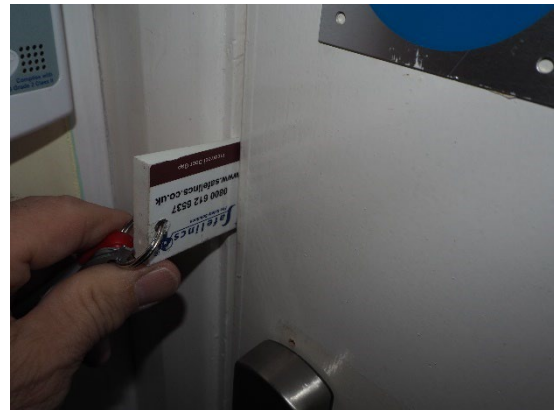
Fire doors were checked for alignment of doors, gaps at head and sides, the door closers were checked as were hold open devices.

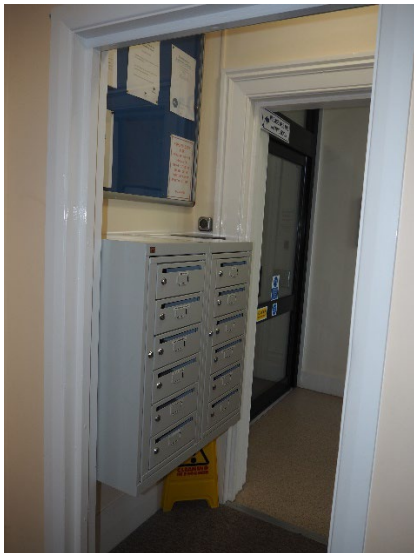
Items are secured where required under lock and key.

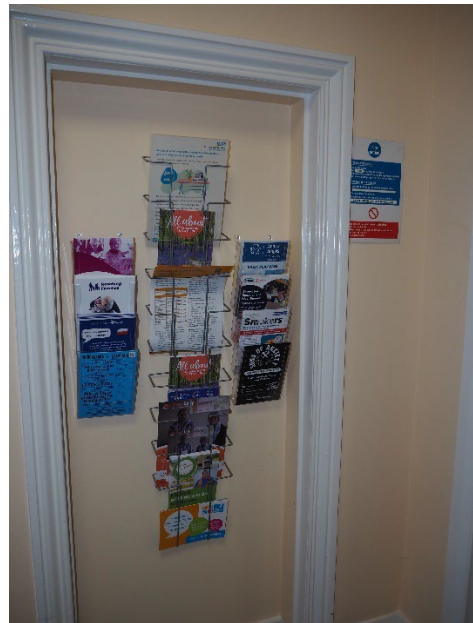
Information leaflets are kept to a minimum.

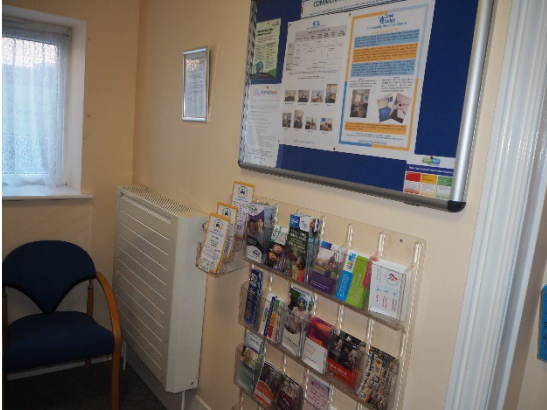
Information posters are kept on a notice board in the waiting area.

We are providing advice on Notice boards and leaflet racks as these can increase the fire loading.

Basically, to keep information to a minimum, have notice boards covered with Perspex and keep leaflets, and brochures to a minimum restocking where necessary.

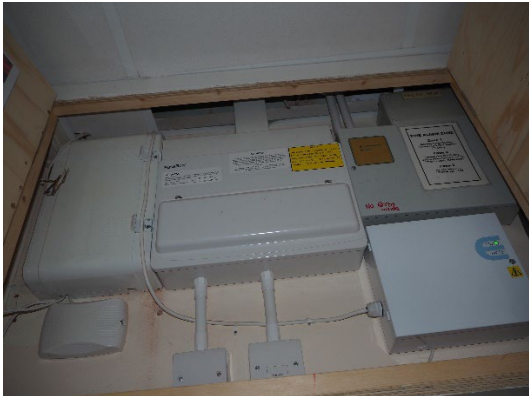
Consumer units / distribution boards were checked.

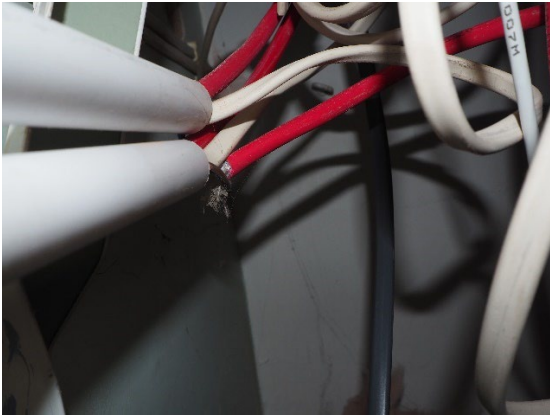
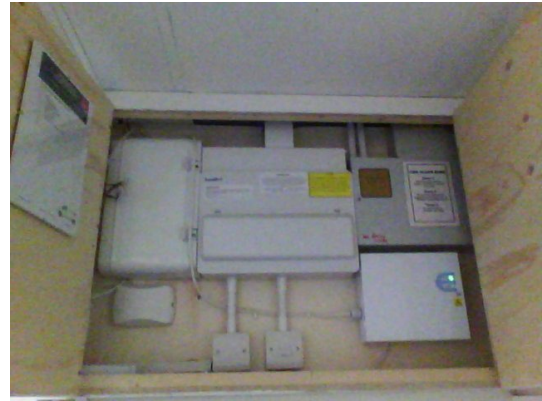
Location of ground floor electric cupboard – suitable danger electric warning sticker should be affixed to the cupboard.

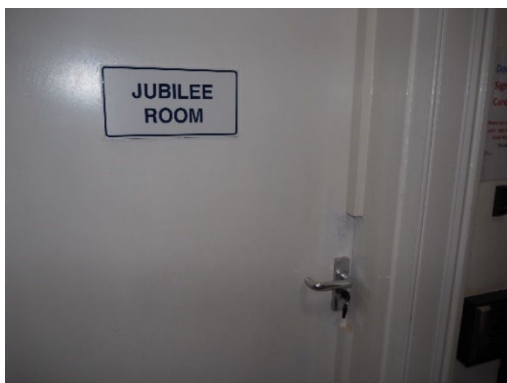
Fire doors were checked for alignment of doors, gaps at head and sides, the door closers were checked as were hold open devices.

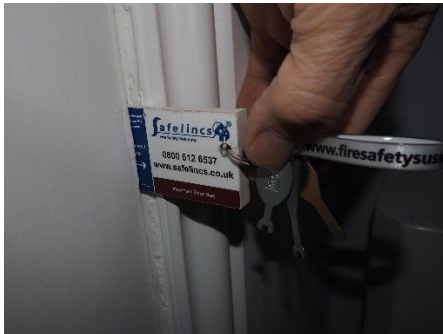
Fire doors were checked for alignment of doors, gaps at head and sides, the door closers were checked as were hold open devices.

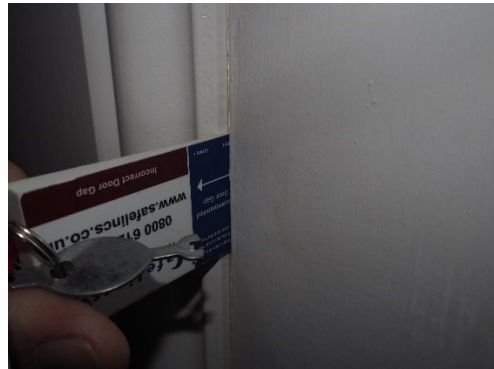
Fire doors were checked for alignment of doors, gaps at head and sides, the door closers were checked as were hold open devices.

Intumescent seals and cold smoke brush strips were checked.

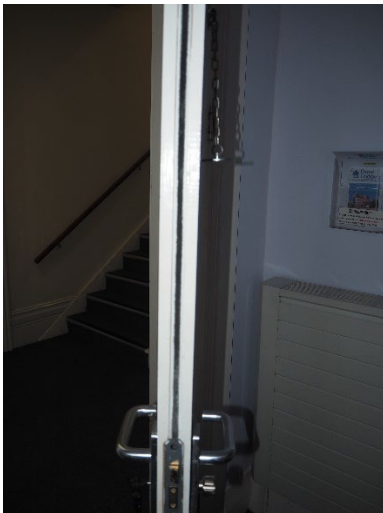
Cupboards were checked.

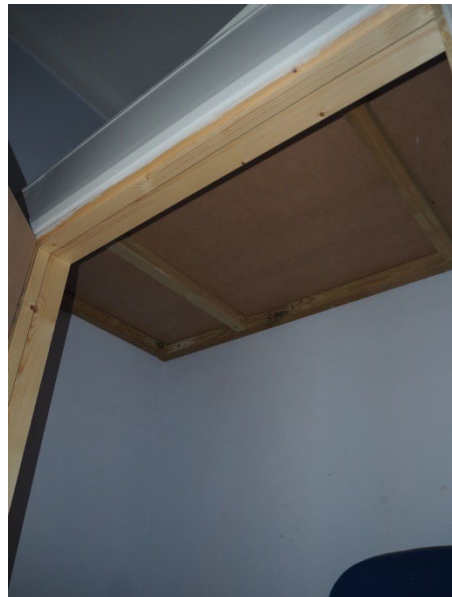
Fire action notices are fitted along with plan of building relevant to which level floor in each room.

Where doors are held open there are approved devices fitted which release when the fire alarm activates.

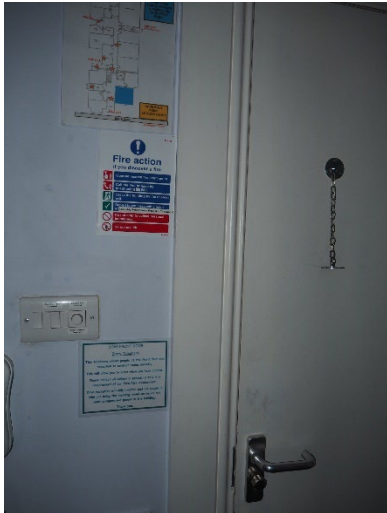
Disable toilet facilities are provided on each level.

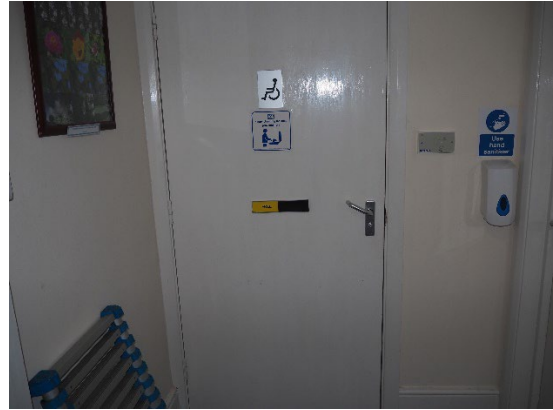
There are emergency lights, fire alarm repeat sounders / strobes installed in the toilet facilities.

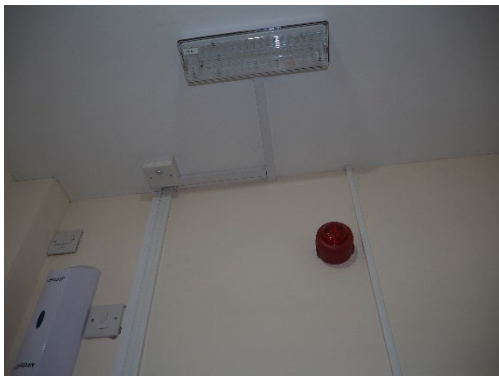
Each of the disabled persons toilet facilities are fitted with an emergency alarm pull cord.

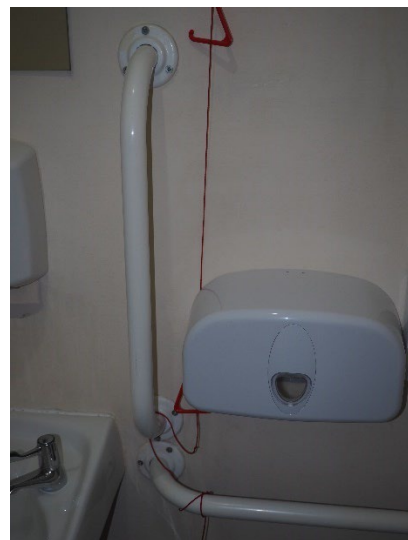
Room 3 The Emergency Lights were checked. This room appeared not to work we found they had accidentally been left on and had discharged.

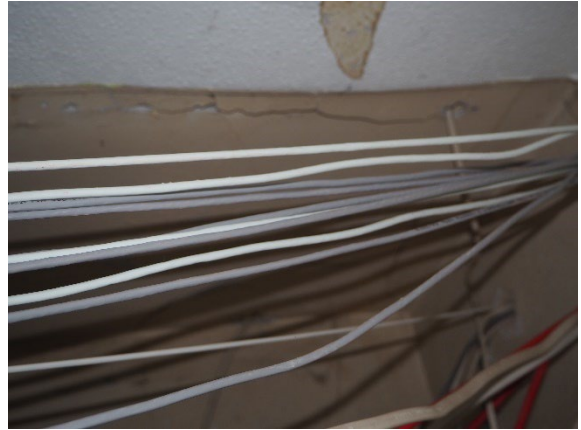
Please refer to comments and Wiring regulations.

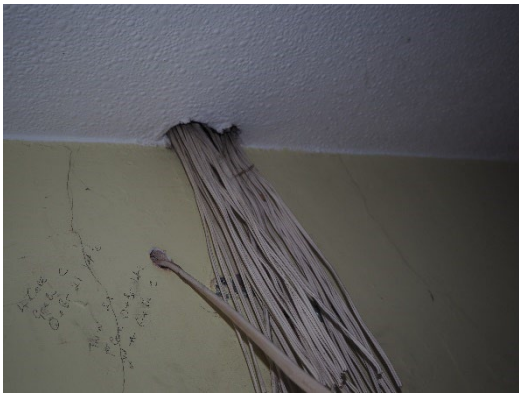
Please refer to comments and Wiring regulations.

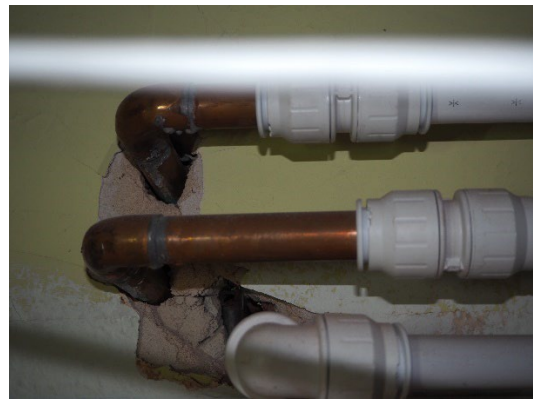
Please refer to comments concerning penetrations and fire stopping.

The reinforced concrete ceiling has been broken through to accept the heating pipes, but this has not been fitted with an approved intumescent collar or any other fire stopping material.

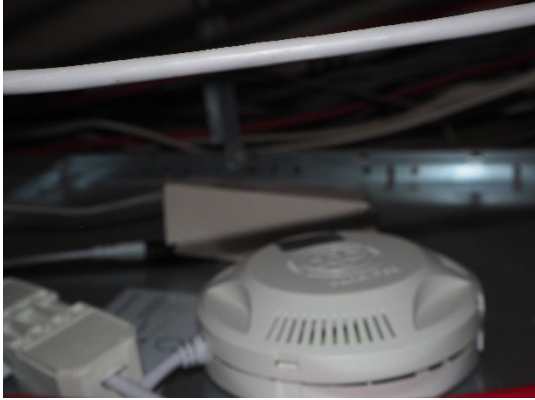
Please refer to comments and Wiring regulations.

Wiring within the loft area is not laid on a grid it is not clipped appropriately, and most cases is covered with insulation. This can cause over heating especially when bundled together not separated or clipped.

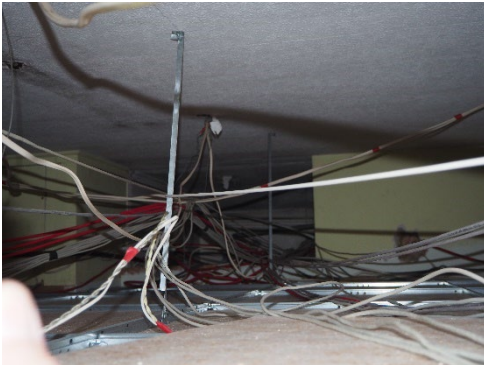
Please refer to comments and Wiring regulations.

Cables are laid hazard often in bundles and criss-crossing other services.

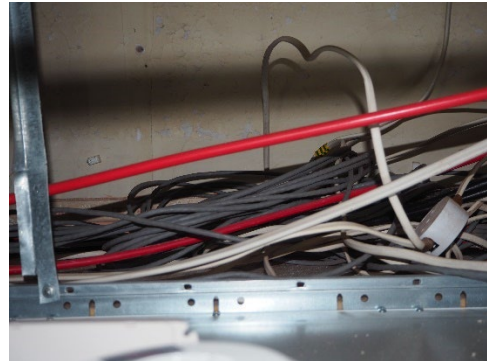
Please refer to comments and Wiring regulations.

The solar gain combined with numerous cables and insulation we consider a hazard with a high-risk rating.
 The periodic electrical inspection is due next year these items should be discussed with them at the earliest stage.
 We will provide separate advice on fire stopping.
 We will provide information on signage, viewing distances, the size of lettering, the style and location.
 We will also provide under separate cover information on Fire doors and maintenance.

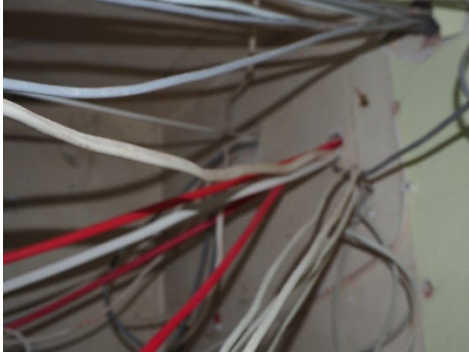
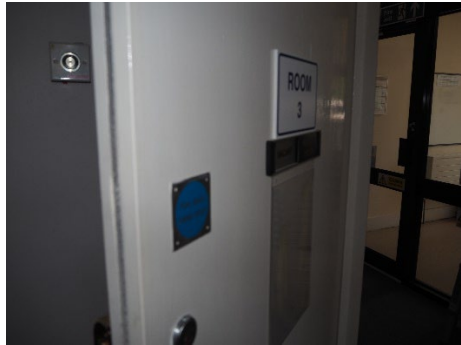
Please refer to comments and Wiring regulations.

Regulation 134.1.1

Where the conductors or cables are not supported continuously due to the method of installation, they shall be supported by suitable means at appropriate intervals in such a manner that the conductors or cables do not suffer damage by their own weight.

Every cable or conductor shall be supported in such a way that it is not exposed to undue mechanical strain and so that there is no appreciable mechanical strain on the terminations of the conductors, account being taken of mechanical strain imposed by the supported weight of the cable or conductor itself.

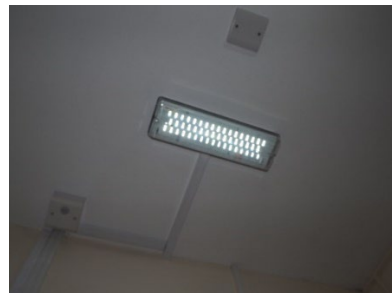
The emergency lighting was checked.

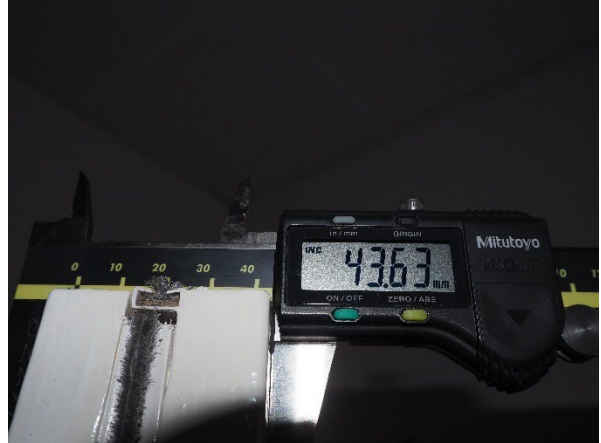
Fire doors were checked for alignment of doors, gaps at head and sides, the door closers were checked as were hold open devices.

Intumescent seals and cold smoke brush strips were checked.

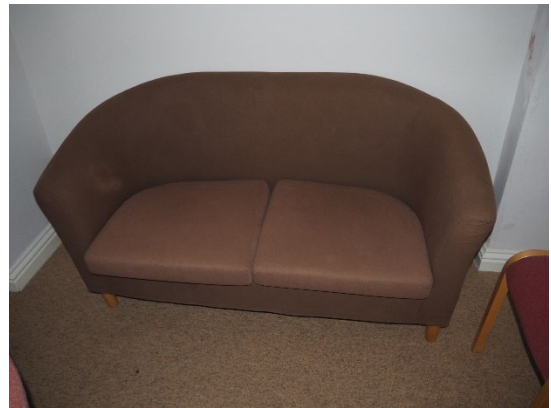
Furniture was checked to ensure compliance with the Furniture and Furnishings (Fire Regulations) 1988/89 as amended 1993 and 2010.

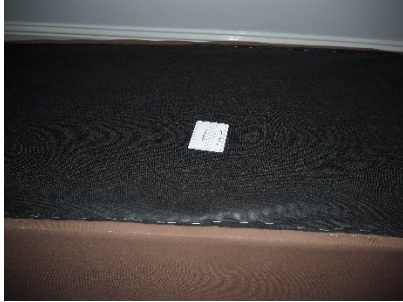
Furniture was checked to ensure compliance with the Furniture and Furnishings (Fire Regulations) 1988/89 as amended 1993 and 2010.

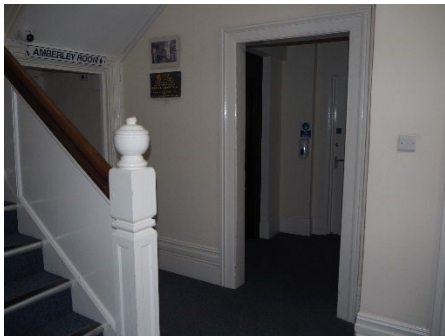
The passenger lift has a sign advising in should not be used in the event of a fire.

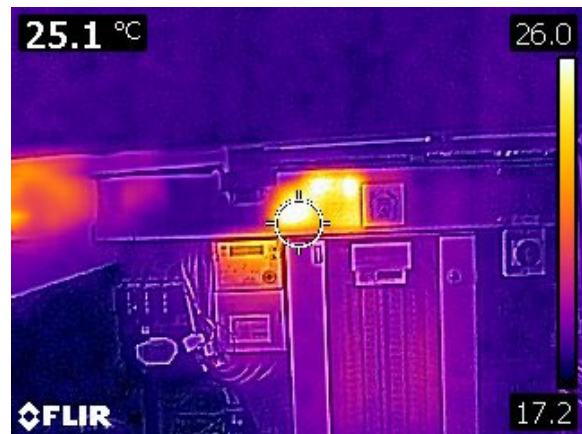
Thermal image of picture to the left.

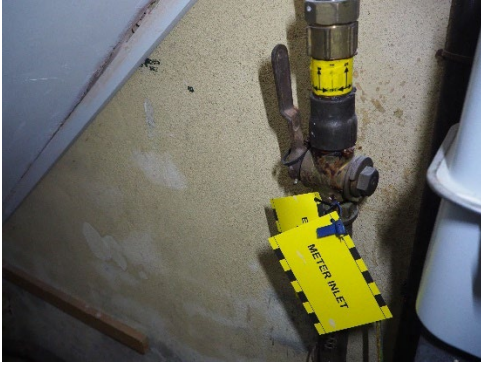
Gas meter inlet- there should be a sign showing which way to turn handel to isolate fitted adjacent.

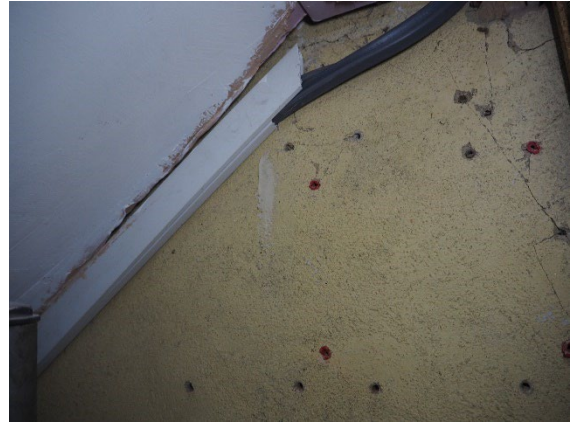
Not all cables are run in a suitable containment.

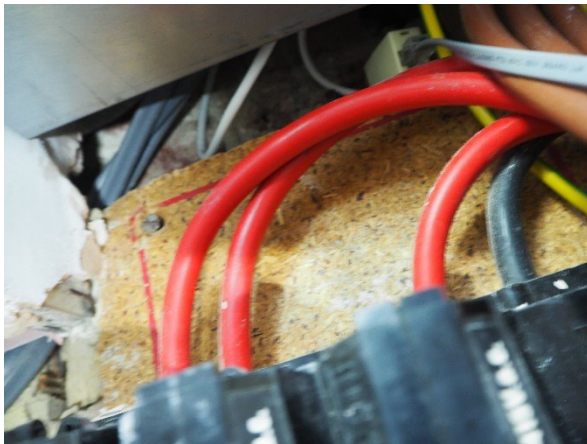
Fire stopping is required around all penetrations.

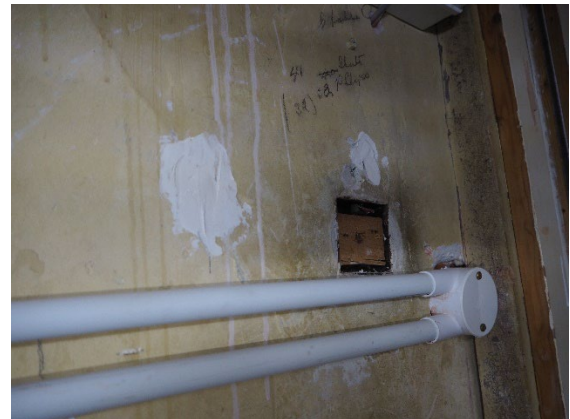
Fire stopping is required around all openings to stop fire or smoke spreading to other floors / rooms allowing poisonous gas to escape.

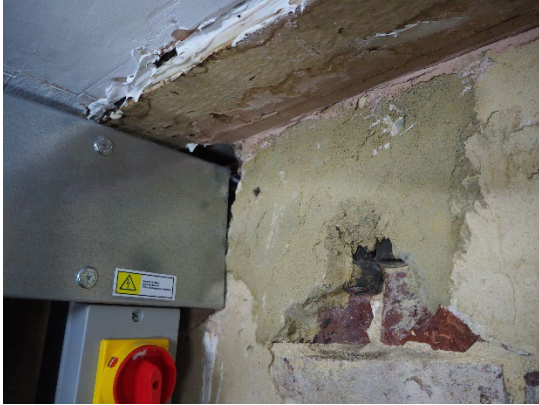
Fire stopping is required around all openings as this will affect compartmentation.

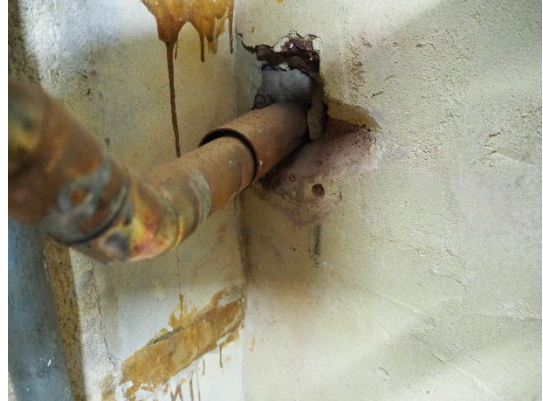
Fire stopping is required around all openings as this will affect compartmentation.

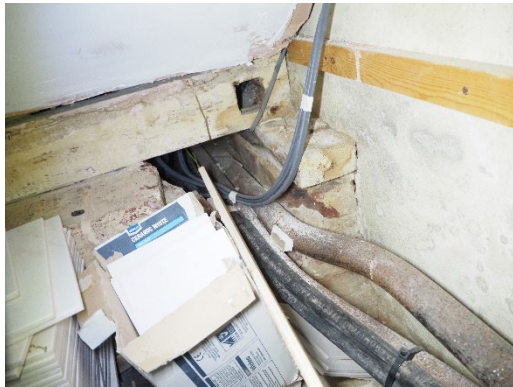
Fire stopping is required around all openings as this will affect compartmentation.

Fire stopping and protection to the underside of the stairs should be 60 minutes fire resistance.

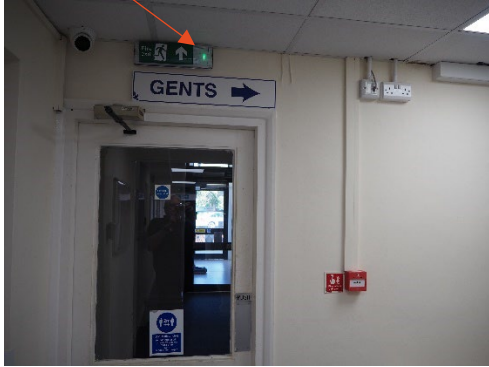
There is a non maintained emergency light above this door.

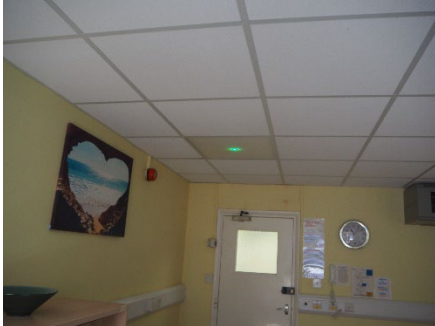
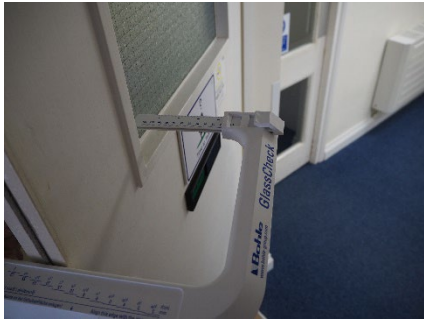
The georgan wire glass when correctly installed with beads intact will normallyn give 30 minutes fire protection.

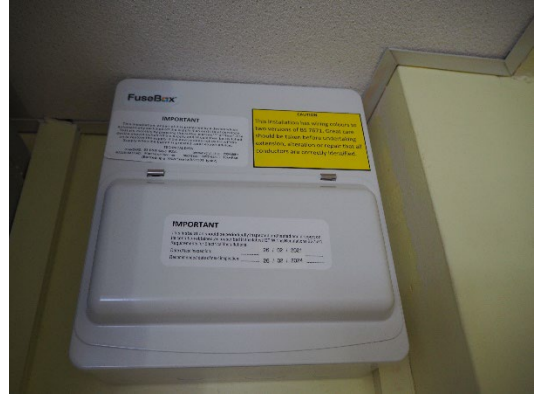
The consumer unit and periodic inspection next falls due February 2024

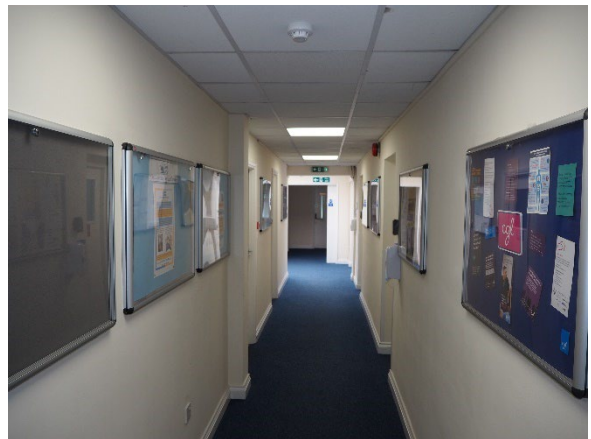
The corridor contains several notice boards which are all covered.

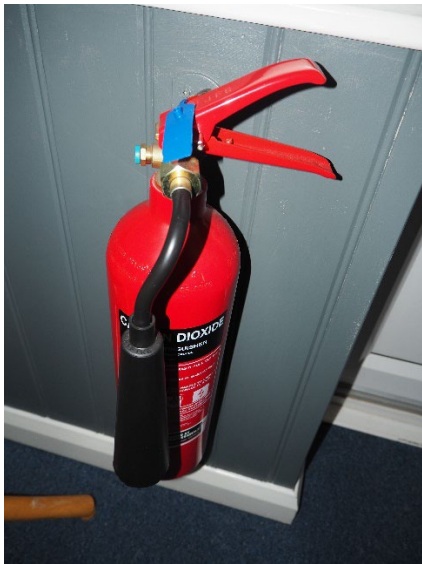
There was a CO₂ fire extinguisher situated close to the final exit door.

There did not appear to be a Fire Extinguisher I.D. sign and we would have though there is a case for a Foam or turbo water mist extinguisher to be installed alongside the CO₂.

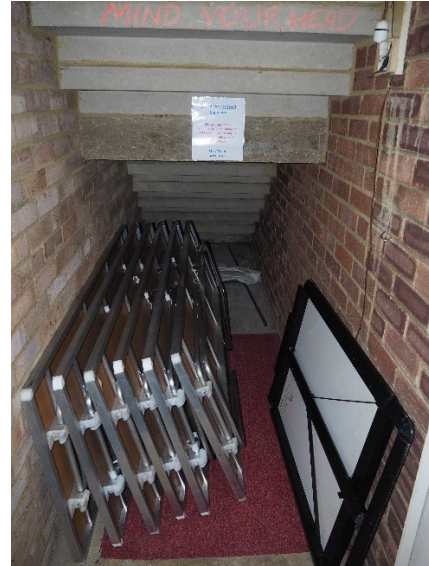
There is a storage cupboard which has been formed under the concrete staircase (which is the Fire well escape route from the first floor).

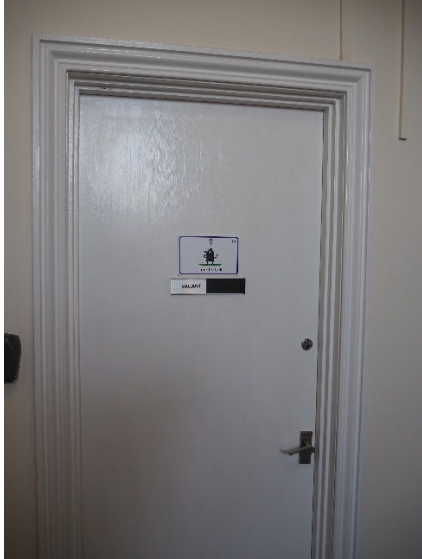
This room contains distribution board and a fire alarm bell is connected to the fire alarm panel.

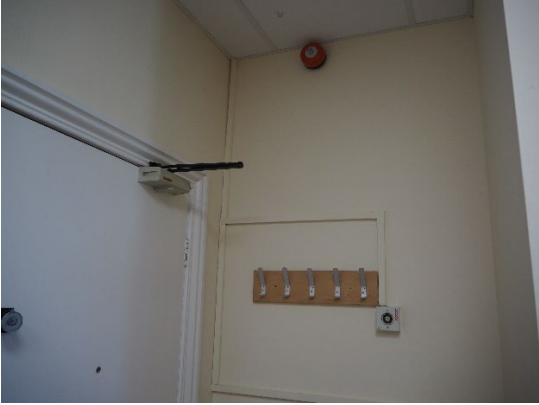
There is both a distribution board and a server no hot spots were seen by means of thermal imaging.

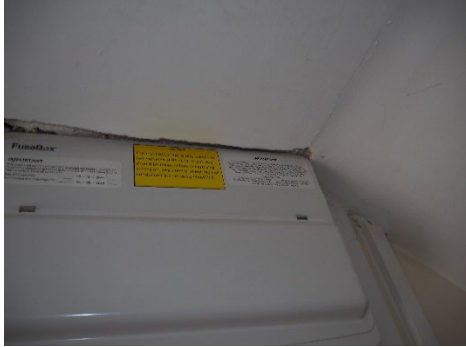
There is a gap above the distribution board and requires fire stopping.

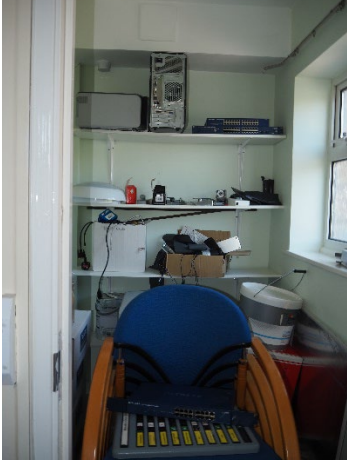
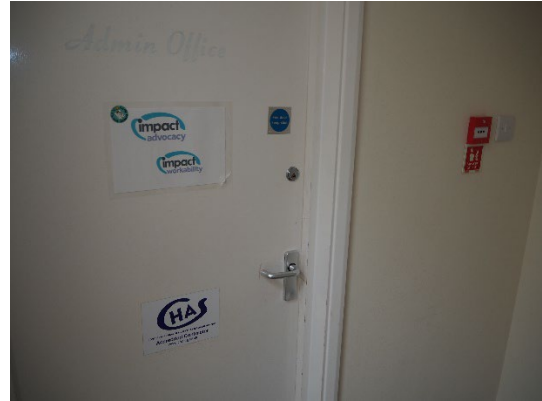
There is a small storage cupboard at the back of this room containing an assortment of items including paint.

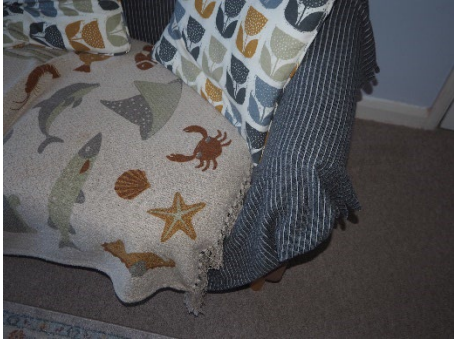
In creating a soft relaxing environment care still needs to be given to fire rated furnishings.

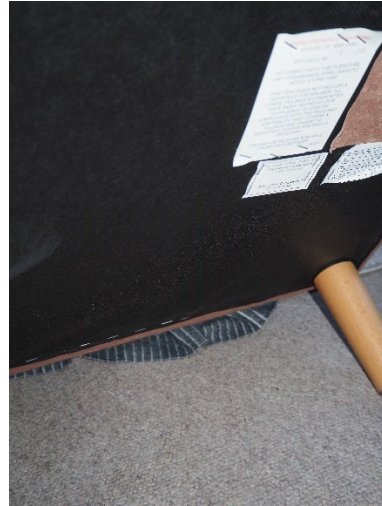
In creating a soft relaxing environment care still needs to be given to fire rated furnishings.

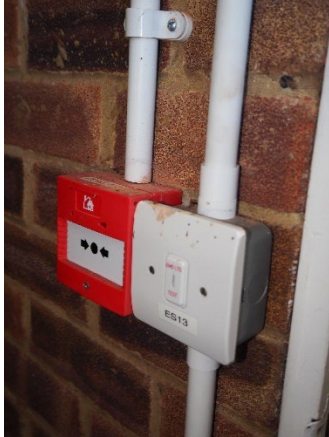
The fire escape stairwell has both break glass call point, smoke detector and emergency light which was tested.

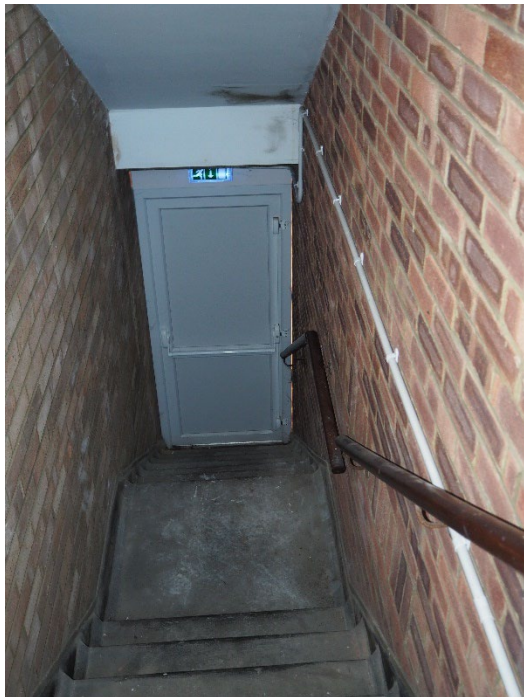
The emergency light was tested.

The final exit door on the fire escape should have a "Push bar to exit" sign we would recommend photoluminescent signs where possible.

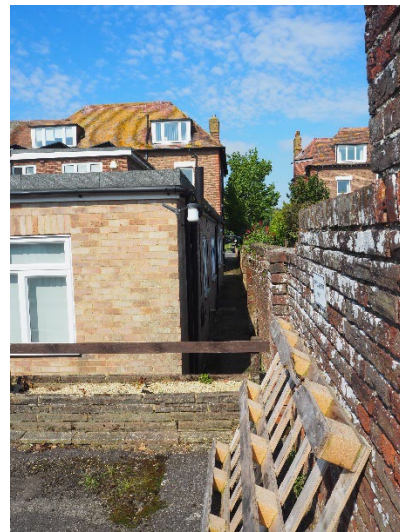
Items such as delivery pallets should be removed in a timely fashion as this presents an opportunity for arson.

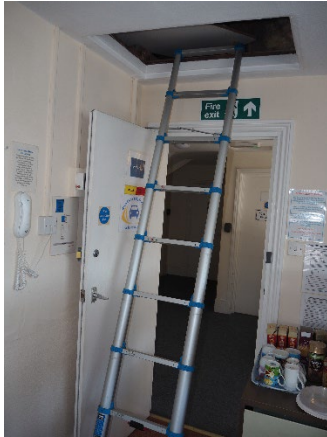
Access to the roof was made through Arun Community Transport ceiling.
